Mysteries Of Maryam Nazre

Kebede Amare and Paul B. Henze

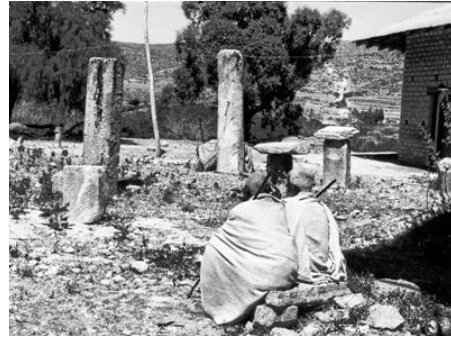
Fig. 2: Aksumite pillars outside the Maryam Nazre church.

It is apparent that the site was significant in Aksumite times. Evidence of Aksumite occupation is visible everywhere. The immediate surroundings of the great stone building, which is termed a church by the villagers and long used by them for this purpose², are littered with Aksumite columns and other cut and shaped stones of Aksumite type. Several Aksumite columns have been incorporated into various parts of the building. More than a dozen columns and other cut stones can be seen outside the building; inside another ten can be identified, some apparently incorporated into the structure in the course of rebuilding. Others may lie buried in the surroundings.

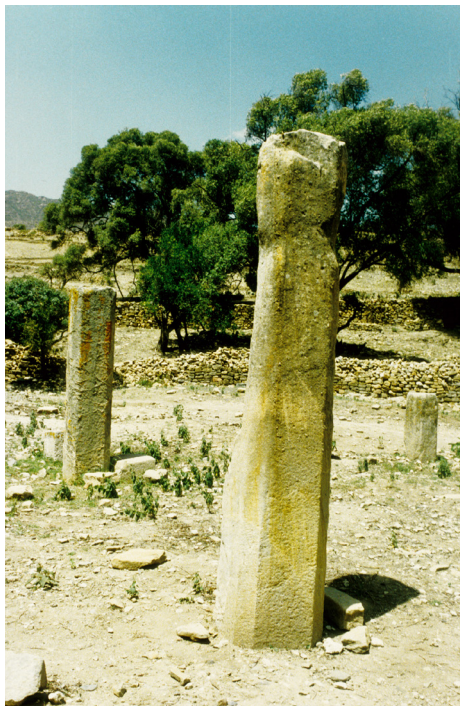
Fig. 3: Aksumite pillars outside the Maryam Nazre church.

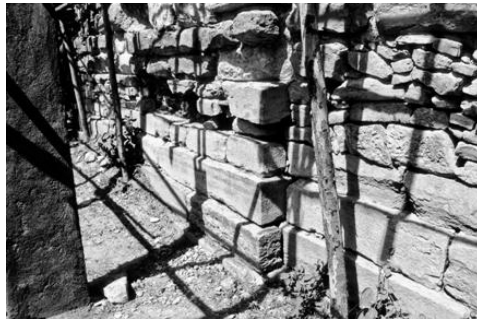
Fig. 5: Aksumite remnants, back-wall of the old Maryam Nazre church.

The most impressive evidence of Aksumite beginnings is in the building's foundations, especially on the east side, where carefully fitted cut limestone blocks form the lowest visible portion of the foundations. A few of the lowest foundation stones reach 1.7 meters in length and 20 centimeters in thickness. These foundations resemble those of the great temple at Yeha and in places such as the church of Maryam T'aqot (T'ehot) south of 'Edaga Ḥamus.³ On the east side of the building, soil has fallen away from the foundations, though not so much as to expose the lowest layer of foundation stones. On other sides of the structure the lower layers of the foundations are not visible at all. We assume, nevertheless, that the walls of the building are underlain by well constructed foundations on all sides. There are no indications of sinking of the foundations. Excavation on all sides would be desirable to determine the foundations' depth. Test excavations by Tekle Hagos, an archaeologist from the Ethiopian Authority for Research and Conservation of Cultural Heritages (ARCCCH), revealed that a structure similar to the one on the eastern side is still intact and extends some 20 meters east-west.

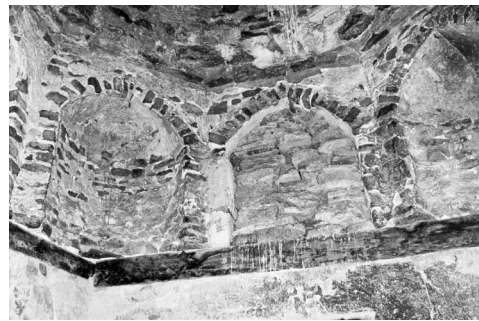
Fig. 6: Niches in one of the three inner chambers.

Each of these rooms has two tiers of arched niches, one above the other, built of carefully fitted stones set in mortar with evidence of extensive original plastering. A good deal of wood has been used with long beams placed between the upper and lower levels. Most of the niches are deep, up to 64 centimeters, and would thus offer room for objects that could have been displayed. There is no evidence

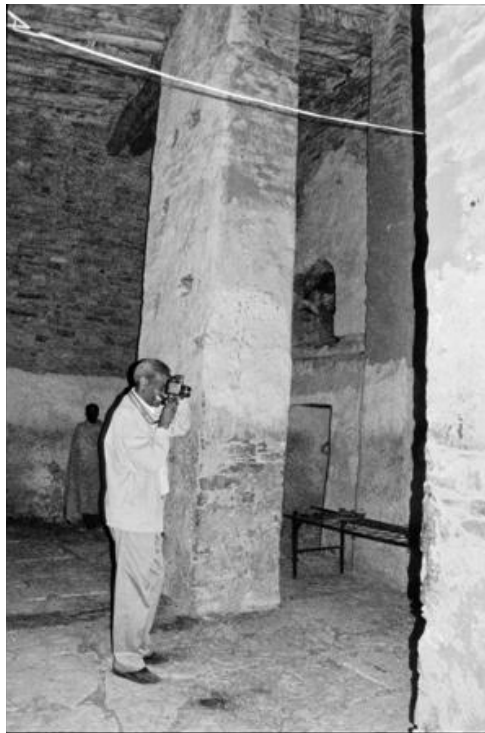
Fig. 7: The inner hall of the old church.

The long hall which forms the western side of the Maryam Nazre building has several Aksumite-type columns, at least two of which are free standing and others which have been incorporated into the walls. The large columns which rise to support the roof give the impression of having been built at a later date of small cut stones, some of which at the top of the columns resemble bricks set in mortar. At several points thin, square slabs lie on the floor or lean against walls. These look like Aksumite altar components. Against the wall outside Room #4 what appears to be a baptismal font rests on one of these slabs. It is round, with a radius of 15 cm. and has an edge, cracked on one side. Below it is an inscription, "*ma - qe - ??*". The floor of the western side of the building consists of flat stone slabs and appears to have been laid at a late date, perhaps over an earlier floor. There is no evidence of crypts or cellars.

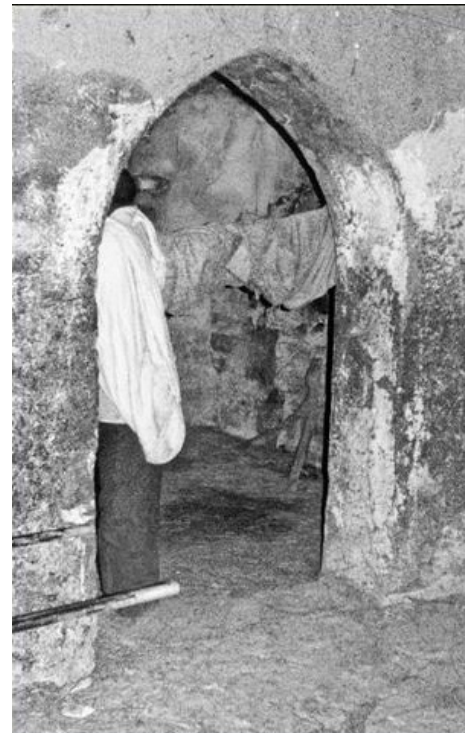
Fig. 8: One of the inner doors in "Islamic" style leading to an inner chamber.

Room #3 is somewhat larger, 4.2 x 4.1 meters. It connects to the main hall by way of an Islamic-type pointed arch which has been neatly plastered, as is a large section of the wall through which it opens.

Room #5 is similar but a bit larger, 3.43 x 3.62; it also connects to the main hall by a lintel-topped door. The doors of these last two rooms have arched interior windows above them which have been plastered and resemble in style the shape of the Islamic-arch door which opens from Room #3 into the main hall.

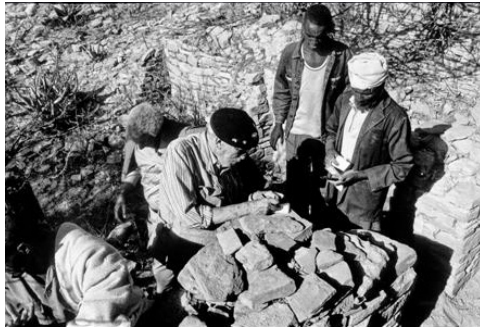
Fig. 9: Ancient walls outside the old church.

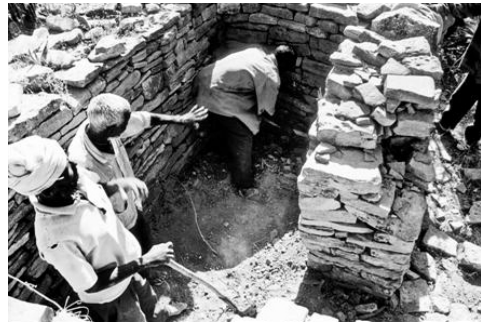
Fig. 10: Ancient structures outside the old church.

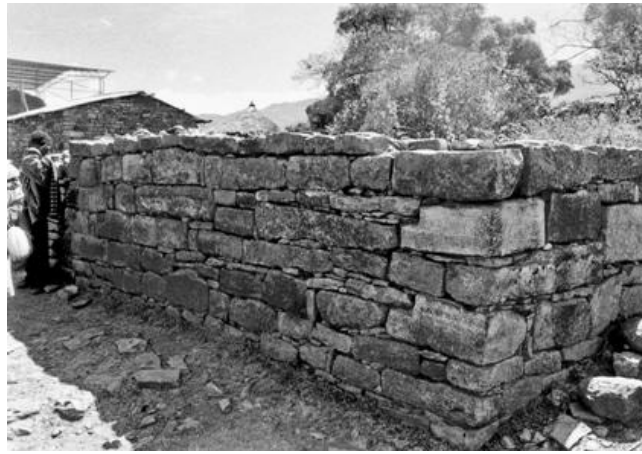
Fig. 12: Remnants of an Aksumite building nearby the church.
